Up to 90% Less Cleaning

## EnduroShield Water Repellency Test

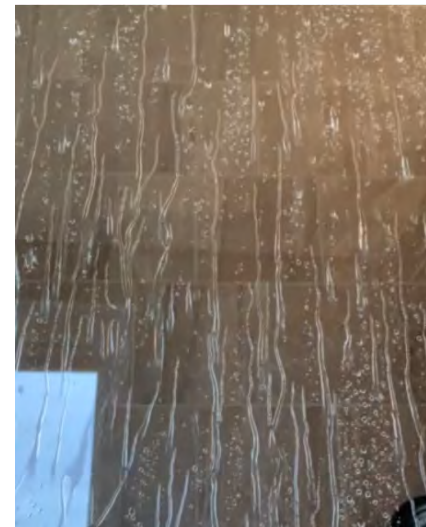
Fig 1: Treated Glass

### Treated EnduroShield glass will behave as follows (Refer fig 1 and 2):

Water will snake down the glass in thin rivulets and create round beads or droplets that will sit high on the treated glass surface due to its repellent nature.

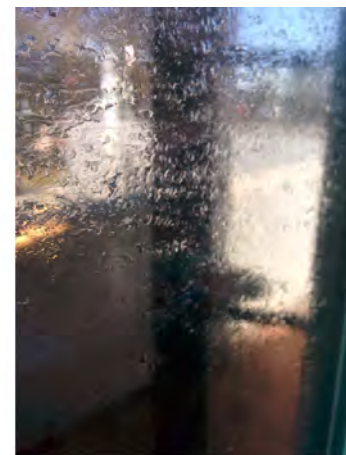
Fig 3: Untreated Glass

### Untreated EnduroShield glass will behave as follows (Refer fig 3)

Water will sheet down the glass over a larger area and maintain a flat appearance
